# P220 ANALYSIS OF THE MARCH 30, 2011 HAIL EVENT AT SHUTTLE LAUNCH PAD 39A

John E. Lane\*  
Easi-ESC, Kennedy Space Center, FL, USA  
Nolan J. Doesken  
Colorado State University, CO, USA  
Takis C. Kasparis  
Cyprus University of Technology, Lemesos, Cyprus  
David W. Sharp  
National Weather Service, Melbourne, FL, USA

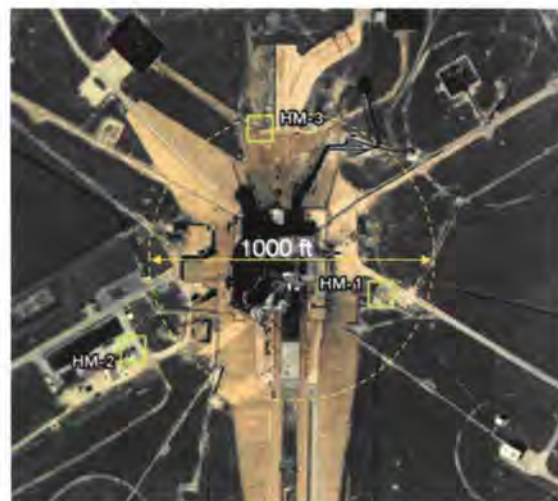
Figure 1. Location of three hail monitor stations, approximately 500 ft from launch pad center.

The KSC Hail Monitor System (HMS), consisting of three stations positioned approximately 500 ft from the launch pad and forming an approximate equilateral triangle, as shown in Figure 1, was first deployed to Pad 39B for support of STS-115. Two months later, the HMS was deployed to Pad 39A for support of STS-116. During support of STS-117 in late February 2007, an unusually intense (for Florida standards) hail event occurred in the immediate vicinity of the exposed space shuttle and launch pad. Hail data of this event was collected by the HMS and analyzed (Lane, 2008).

The HMS was routinely deployed a few days before a space shuttle roll-out and retrieved a few days before launch. Due to a hazardous operation at the time of deployment for STS-134, the location of HM-2 was at an alternate site, approximately 40 m NW of the site shown in Figure 1.

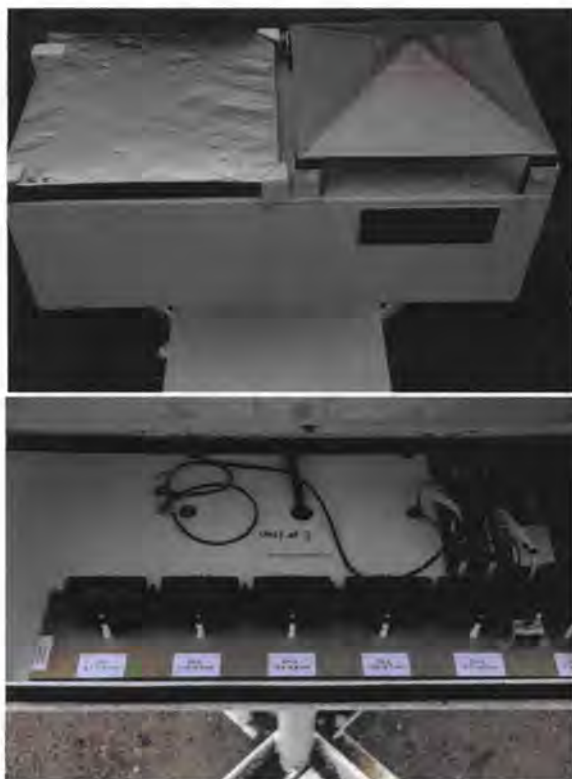
Figure 2. Hail monitor system (HMS): (top) shows hail pad on left and active sensor on right; (bottom) shows the LCD counters for each of the six size channels.

Each hail monitor system consists of two independent measurements of hail size and count (see Figure 2):

1. A *passive* hail pad - 12 [in] square Styrofoam covered with aluminum foil, where an empirical calibration curve is used to convert dent diameter to hail diameter, as shown in Figure 3 (Long, 1980; Palencia, 2011; Lozowski, 1978; Strong, 1977).
2. A 12 [in] square *active* electronic sensor (Lane, 2006) with DSP processing and six LCDs, displays accumulated counts per six size channels. Each size channel represents  $\Delta D = 2$  mm bin width, starting at  $D_1 \approx 9$  mm, ending with  $D_6 \geq 19$  mm.

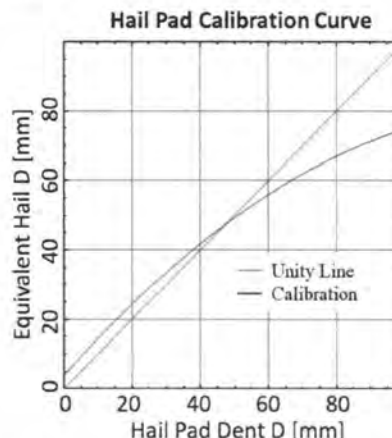
Figure 3. Hail pad calibration curve relating dent size to hail stone size.

Table 4 tabulates the result of counting hail pad dents and converting to equivalent hail stone diameter using the calibration from Figure 3. A custom image processing program was used measure and log the hail dents in the foil images.

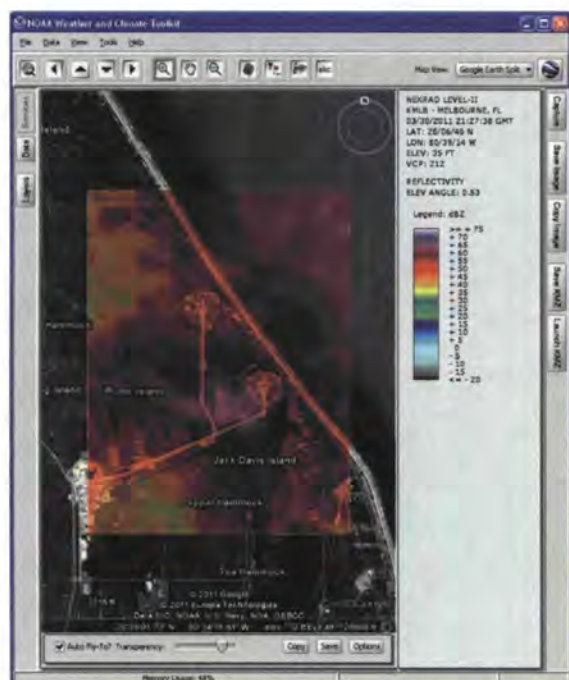
Figure 4a. NWS radar image of March 30, 2011 storm. Purple shows the extent of the hail swath as it approached from the west.

National Weather Service (NWS) NEXRAD, located 55 km south of Pad 39A at the NW corner of the Melbourne International Airport, detected and plotted the approaching hail in near real-time. Figure 4a is a base scan reflectivity plot of the NWS radar image of the March 30, 2011 storm at 21:27 GMT. Purple shows the extent of the hail swath as it approaches from the west. For comparison, the February 26, 2007 event is plotted in Figure 4b. The difference in intensity of the hail is obvious in this comparison.

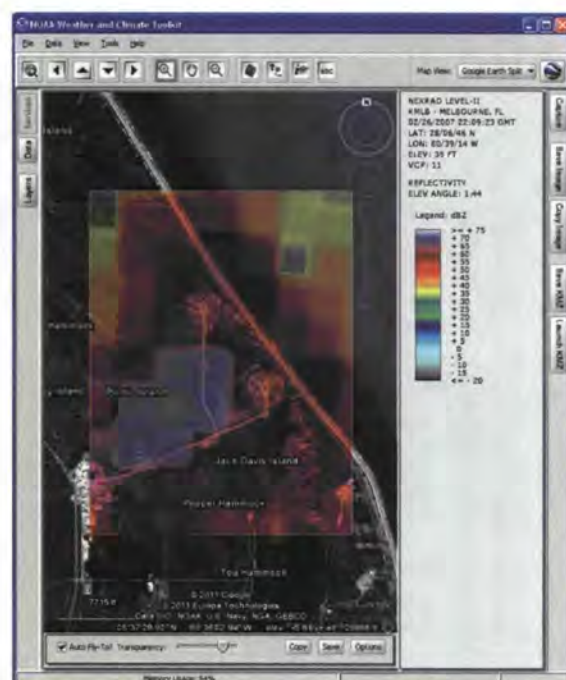
Figure 4b. NWS radar image of February 26, 2007 storm. Purple and grey shows the hail swath as it approached from the west.

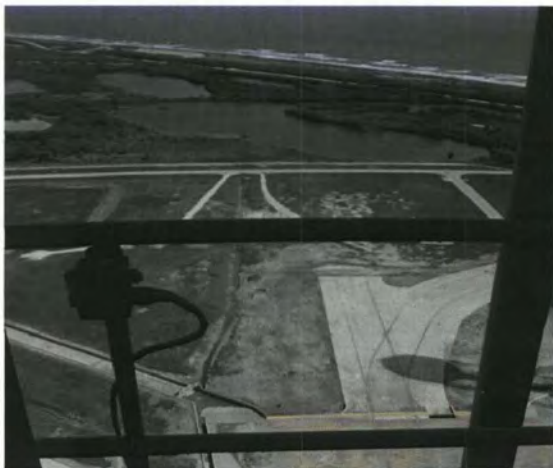
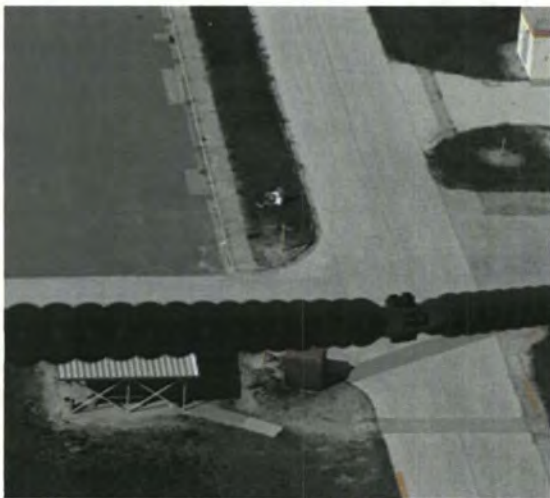
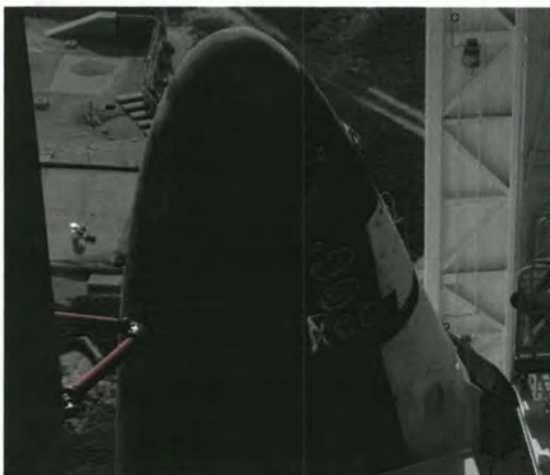
*Figure 5. FSS 275 level view of: (top) HM-3, bottom center of image; (middle) HM-2, center of image; (bottom) HM-1, center of left side of image.*

Because of the high winds associated with the passage of this storm, and the fact that hail was detected at the launch pad by the hail monitor system, as well as NWS radar, a thorough analysis of the hail pads at each station was then performed. Figures 5 show the view of the hail monitor sites from the Fixed Service Structure (FSS). Figure 6 are images of the hail pads at each site, after the hail event. Inspection of the hail pads reveals numerous dents from very small to something approaching to 0.5 [in]. Most of the hail size data associated with this event is contained in the hail pads.

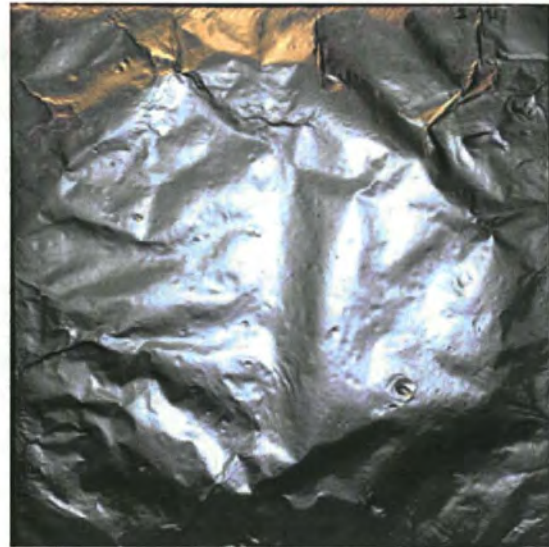
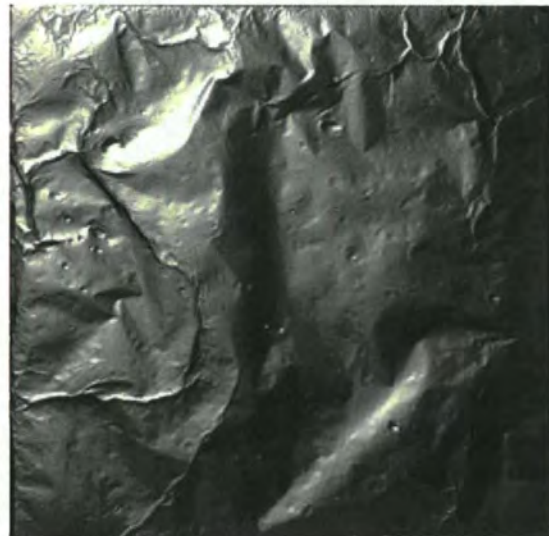
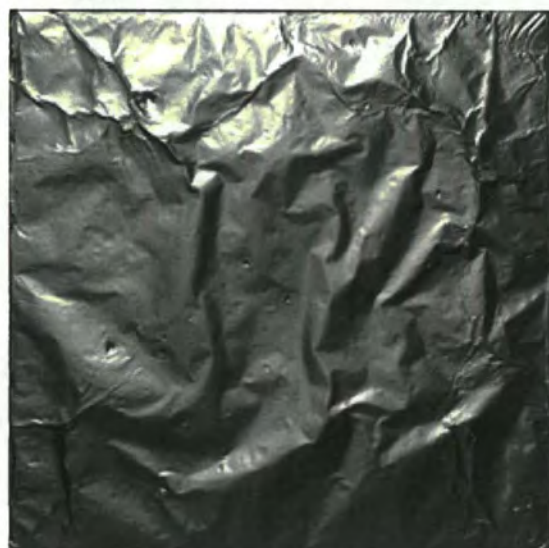
*Figure 6. Passive hail pad showing small dents: (top) HM-3; (middle) HM-2; (bottom) HM-1.*

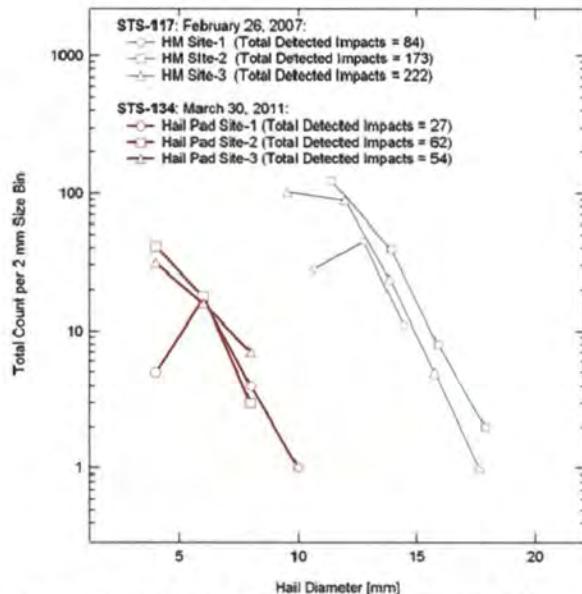
Figure 7. Hail size distributions comparing STS-134 to STS-117 events.

The histogram data from Table 4 can then be plotted with the hail disdrometer data from the STS-117 event for comparison, as shown in Figure 7. Note that the bin size is changed in Table 4 from  $\Delta D = 0.5$  mm to  $\Delta D = 2$  mm in order to properly compare to the hail disdrometer data of February 26, 2007. Figure 8 shows a set of histogram plots for all three systems, comparing the passive hail pad counts to the active disdrometer counts.

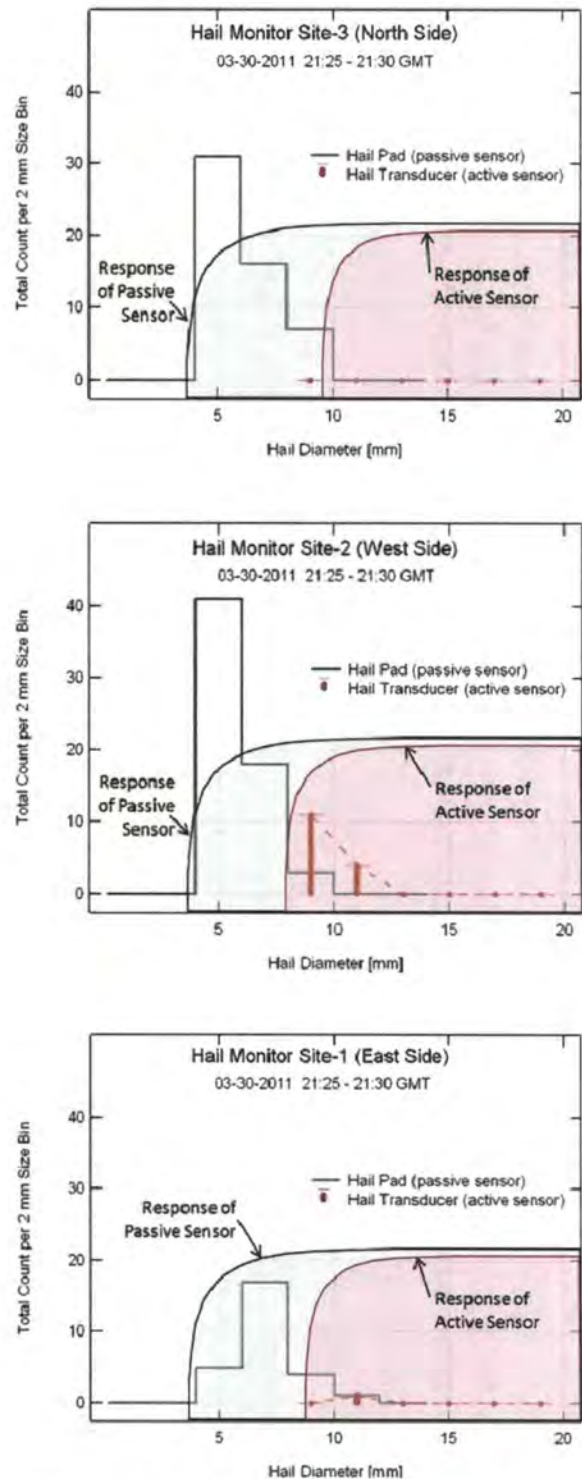
Figure 8. Hail size histograms from HMS: (top) HM-3; (middle) HM-2; (bottom) HM-1.

Upon examining the histograms of Figure 8, it can be seen that the hail pad and disdrometer histograms don't quite line up. One explanation for this is aging of the active sensor which then affects the response. A correction should be applied to the disdrometer calibration as follows: HM-1, no correction; HM-2 shift down by 1 mm; HM-3 shift up by 1 mm.

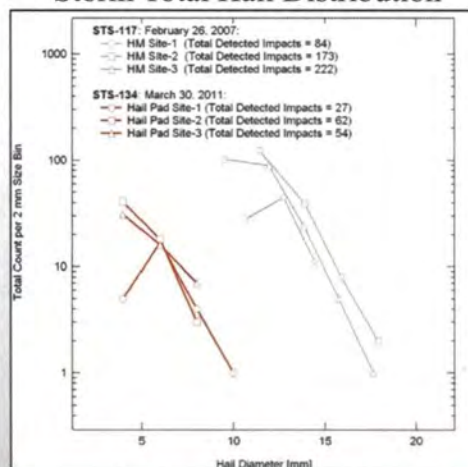
Storm Total Hail Distribution

- During the late afternoon of March 30, 2011 at approximately 21:25 GMT, hail monitor stations at Pad 39A recorded pea size hail while STS-134 Endeavour was preparing for its final flight into space.
- The maximum hydrometeor size detected by the composite measurement of the three hail disdrometers and three hail pads surrounding the launch pad structure was estimated to be no larger than 12 mm, corresponding to the 6 sq. ft. total sensor measurement area.
- Damage to external tank was minimal and repair was not required.

The maximum hydrometeor size, of the STS-134 March 30 event, detected by the composite measurement of the three hail disdrometers and three hail pads surrounding the launch pad structure was estimated to be no larger than 12 mm, corresponding to the 6 sq. ft. total sensor measurement area. The 12 mm maximum size was measured by the active impact sensor at Station-2, located on the west side of the shuttle launch pad. High winds from the west produced a few elongated dents in the hail pads. High winds were also responsible for damage to facilities near hail monitor Site-2, where a dumpster was overturned and a picnic table roof was demolished. NWS radar volume scan showed 60-65 dBZ reflectivity values in the lowest four scan elevations around and over the pad 39A area. Some of the larger passive hail pad dents were shallower than what would be expected from solid frozen ice hydrometeor dents. Therefore, it is possible that the larger pea size hail may have been softer than the smaller rice size hail, consistent with partial melting before reaching the shuttle's fragile external tank outer shell.

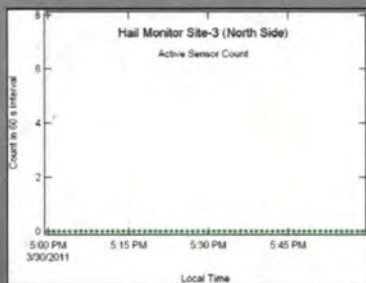
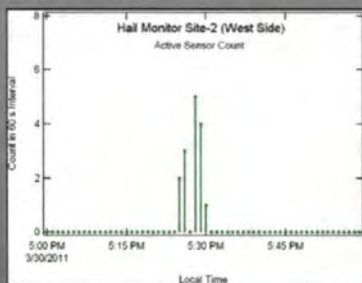
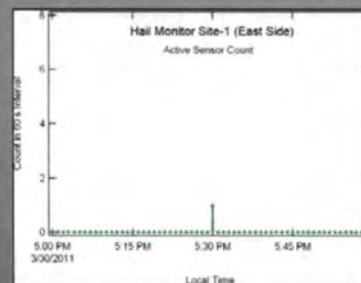
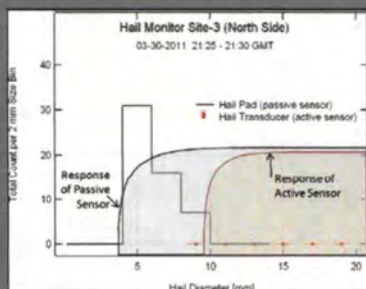
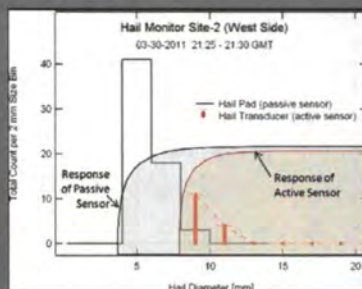
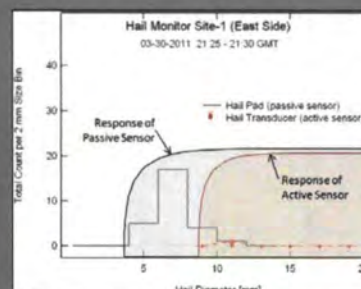
Site-3 Hail Pad

Site-2 Hail Pad

Site-1 Hail Pad

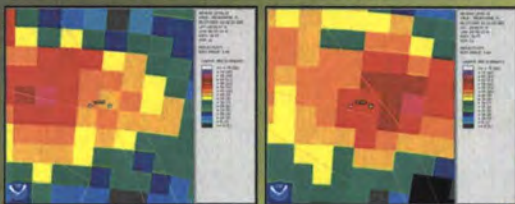
Melbourne NEXRAD

- Hail pad dents indicate very large raindrops.
- Consistent with the occurrence of slushy low density hail.
- No damage to vehicle occurred.

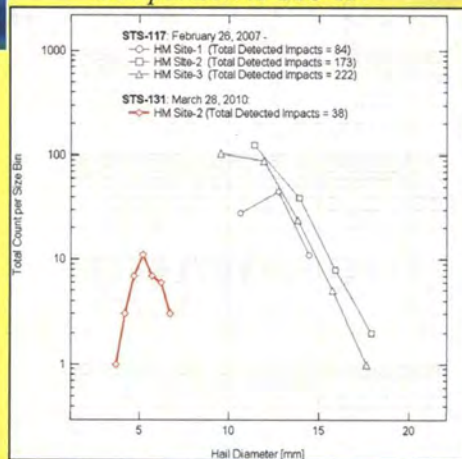
Comparison to STS-117

- Small hail and low count.
- No damage to vehicle occurred.

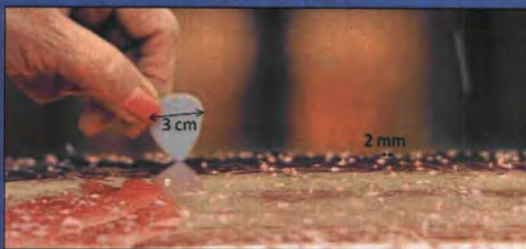
### Sleet Event

- Small sleet pellets.
- No damage to vehicle occurred.
