Ice Ice Baby - Measuring Ice in Vermont

May 20, 2020 - CoCoRaHS Community Presentation

Dr. Jason Shafer, Professor, Northern Vermont University-Lyndon
jason.shafer@northernvermont.edu

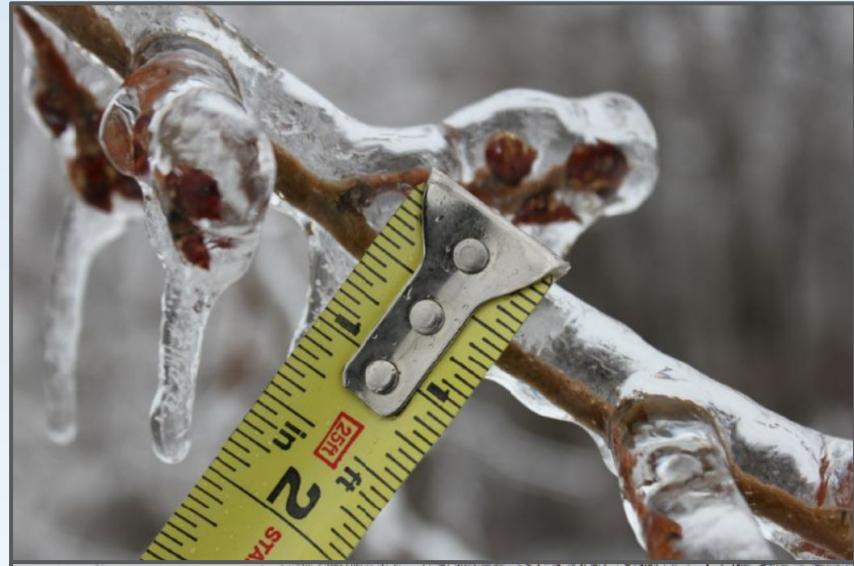
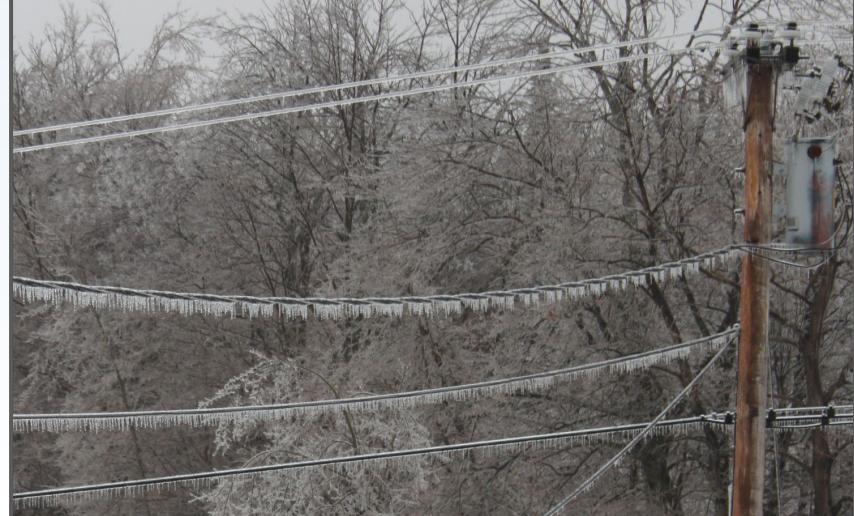
Freezing Rain Icing

- Ice accretion is based upon:
 - Air temperature
 - Wind speed
 - Precipitation rate
 - Material characteristics

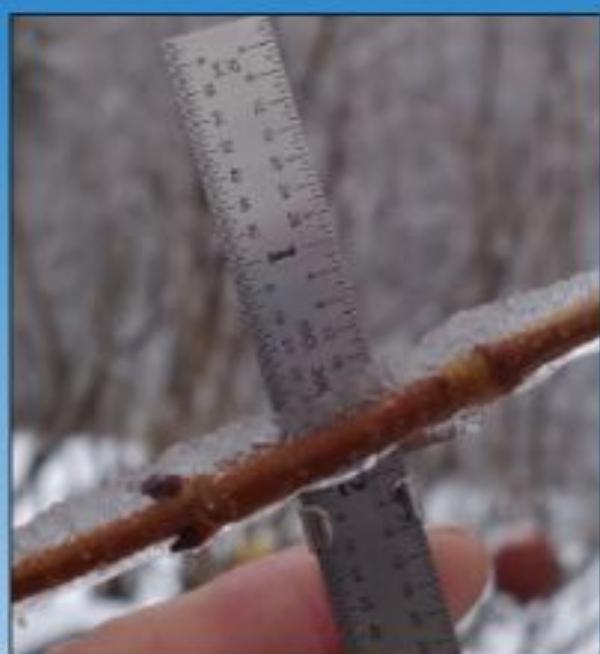
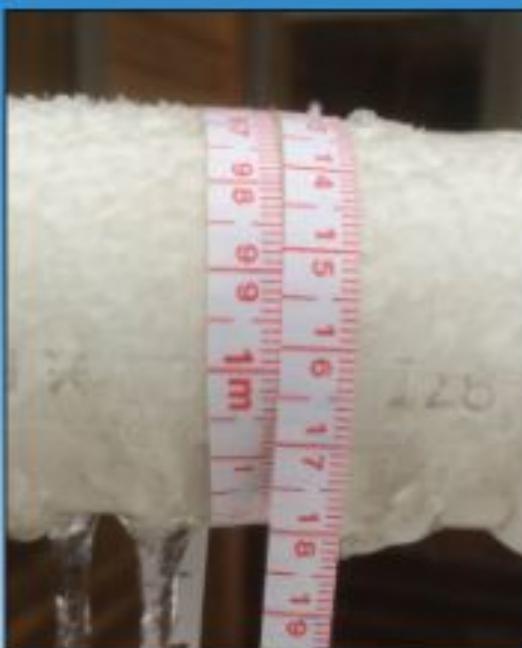
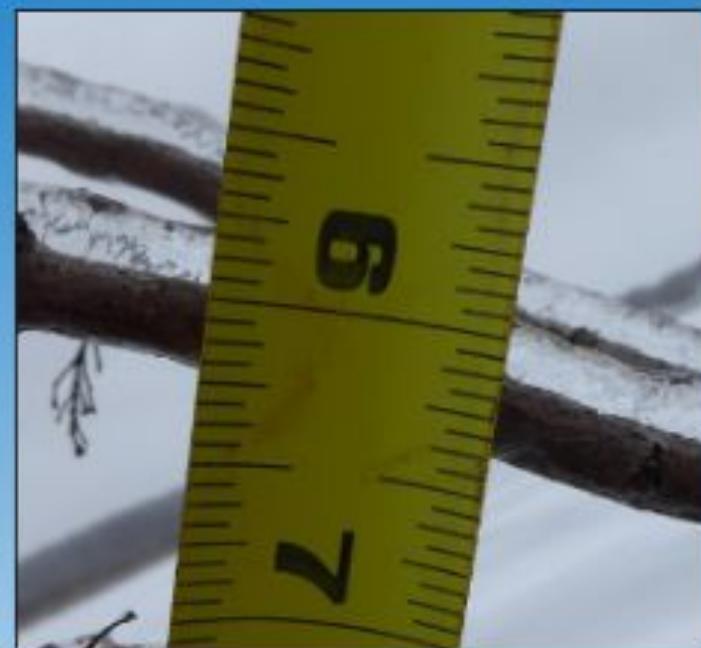
CoCoRaHS observers measurement from Jan 24, 2017 across VT

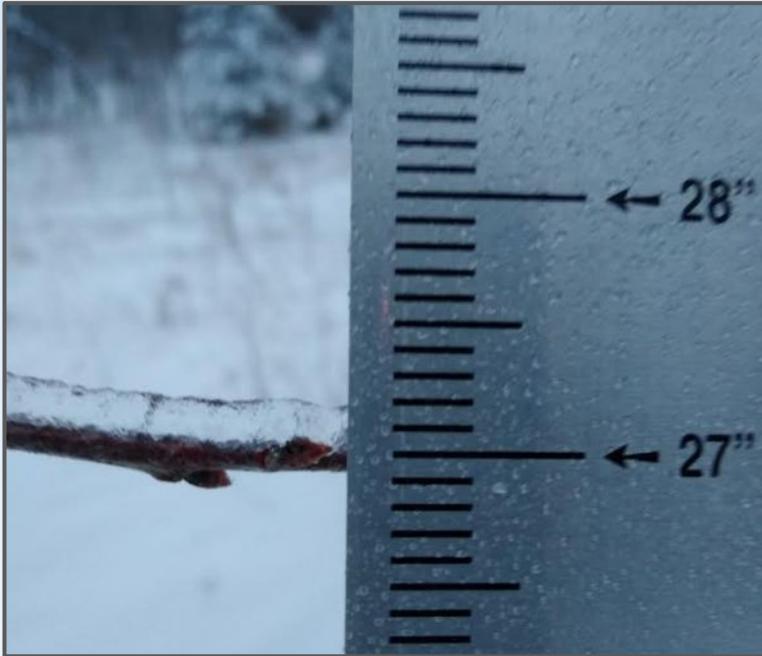
Observation Examples - Feb 7, 2020

As of 2:00 pm we received Number 5 on your report 3/16" measured on twigs and clothes line. Then about 1" of heavy wet snow starting to switch over to finer flakes at 3:00 pm.

On second thought....I just took my dog out for a walk, and on closer inspection, I wonder if we might not be a 3 instead of a 2. The evergreen boughs are weighted down, and there is a nice coating of ice on every twig on the trees. I snapped some shots with my cell phone. If you would like me to text them to you, just send the number and I will do that.
